THE **BOEING** COMPANY
AERO-SPACE DIVISION
SATURN BOOSTER BRANCH

DOCUMENT NO. T5-6539-80

TITLE METALLURGICAL ANALYSIS OF FILTER HOUSING ASSEMBLY,

60B83104-1, SERIAL NUMBER 69 FAILURE

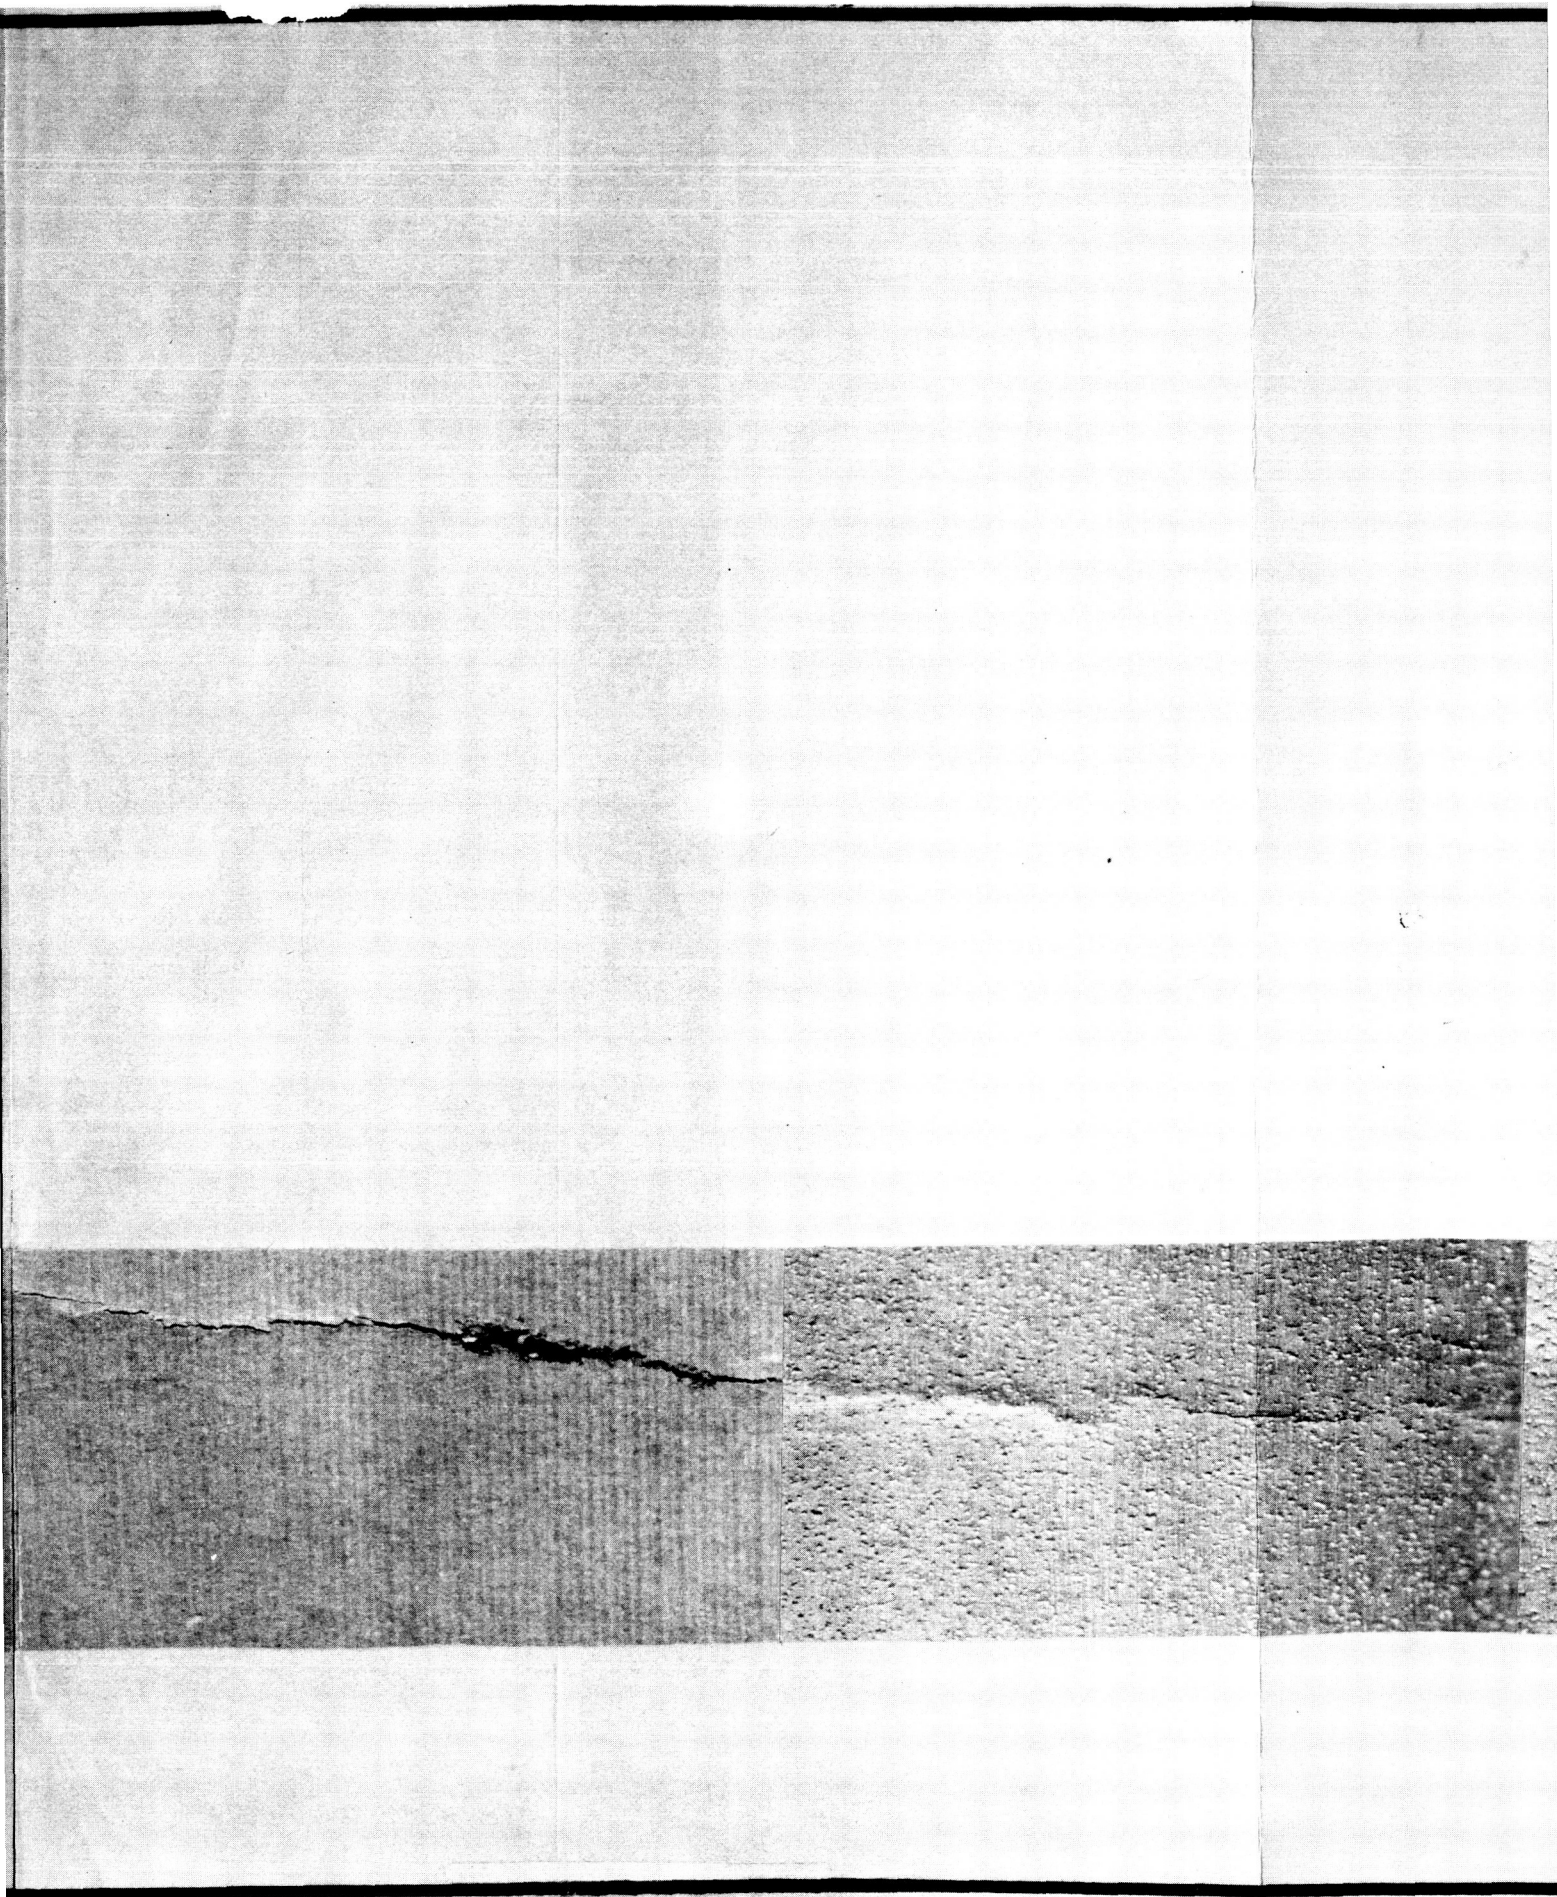
Figure 5 - Fractograph of Portion of Crack, 3X

Figure 5 is a fractograph of a portion of one of the cracks. The initiation point of this crack, on the interior surface of the housing is indicated in figure 5. The fracture face has a granular

Initiation

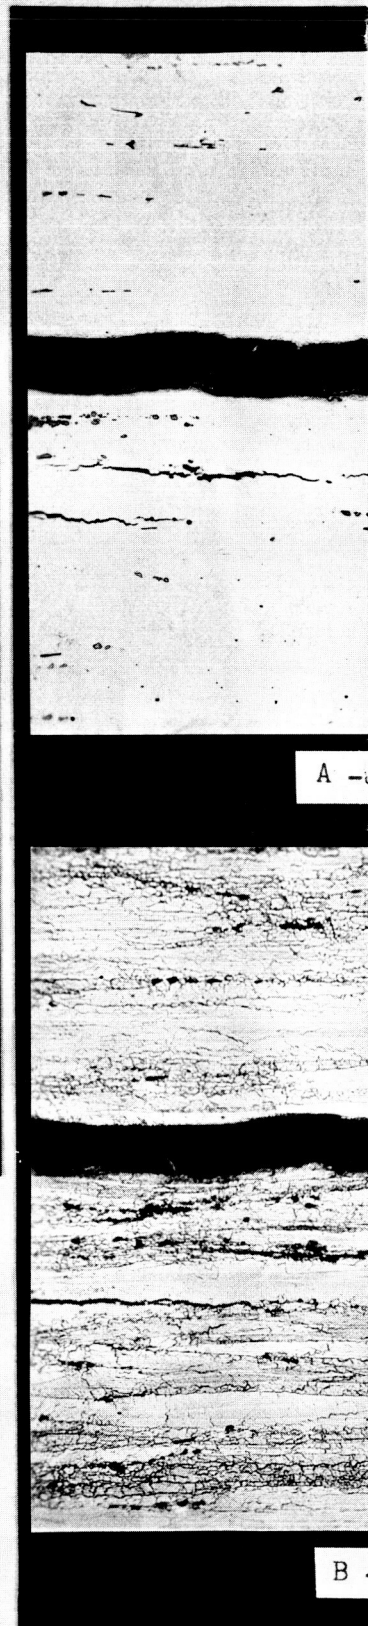
Figure 7 - Mic

rostructure of radial specimen
